AFWAL-TR-80-3132
Part II

ALTERNATE T-38 TRANSPARENCY DEVELOPMENT
Part II: Baseline Birdstrike Testing

Final Technical Report for Period June 1979 - October 1980

December 1980

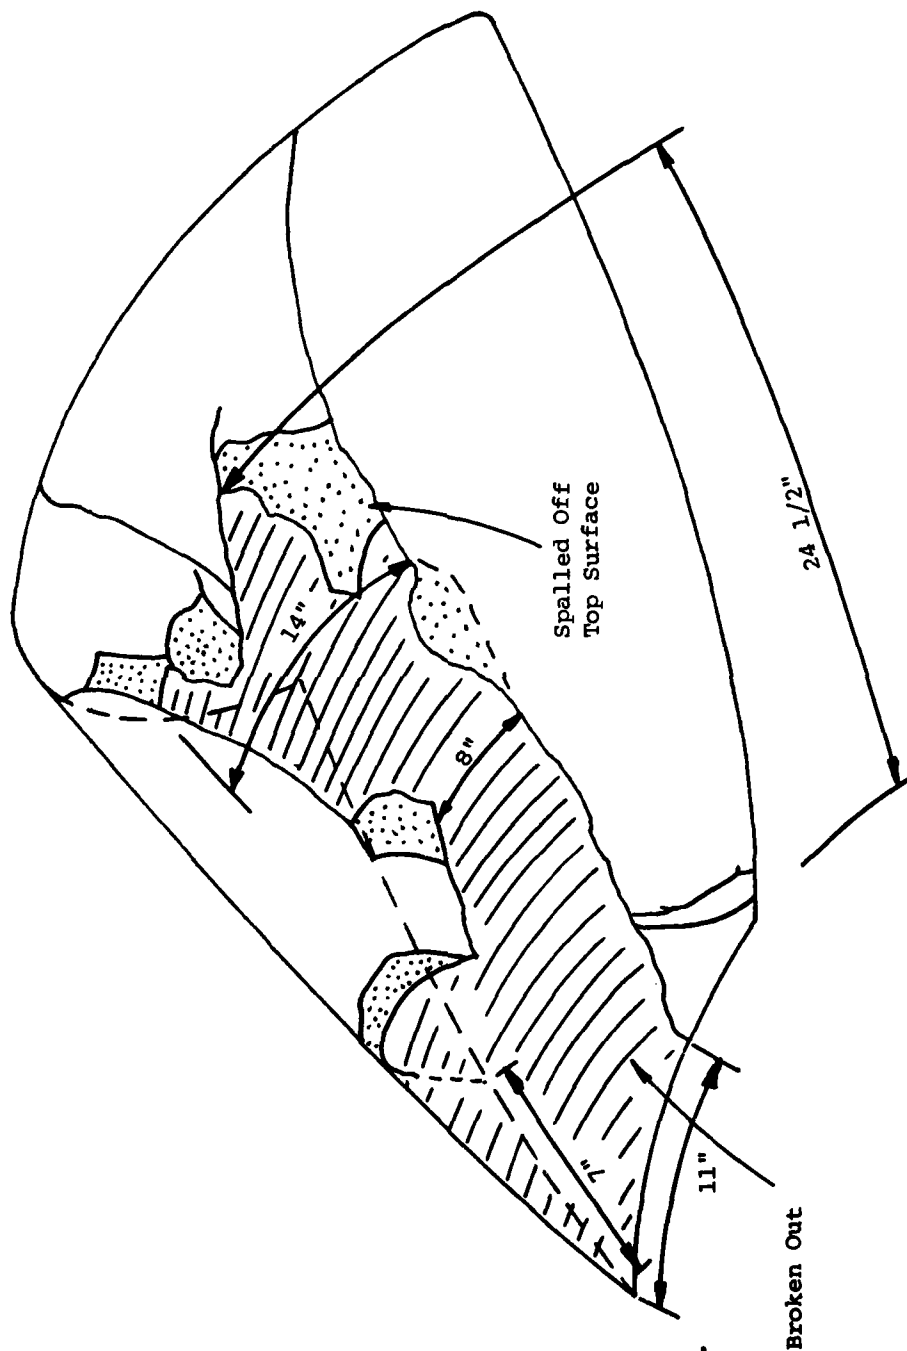
was 236 knots. All components were the same as in Test No. 632. The transparency failed catastrophically with approximately 30 to 40 percent of the bird penetrating the cockpit. The bird orientation prior to impact looked good and impact was at the desired location. Analysis of the films showed little, if any, apparent motion in the forward fuselage. Visual observation revealed no apparent damage to the windshield support structure or mounting hardware. The transparency had cracked through to its leading edge at the front bulkhead center screw location. This was discovered when the transparency was removed from the frame. The windshield arch-canopy frame gap measurements are shown in Table 2. The test established that the catastrophic failure velocity for impact location 1 is equal to or less than 236 knots. The characteristics of the failure are shown in Figures B-1, B-2, and B-3.

1. Catastrophic failure (see sketch and photograph, Figures B-1 and B-2).
2. 30-40% of bird penetrated.
3. No visible damage to support structure or mounting hardware.
4. Bird location and orientation looked good.
5. Appears to be little, if any, motion in forward fuselage.
6. Measured gap change between windshield frame and canopy frame (see Table 2).
7. Transparency was cracked through to edge at front bulkhead center screw location.

Figure B-1. Sketch of T-38 Forward Windshield After Test No. 633.

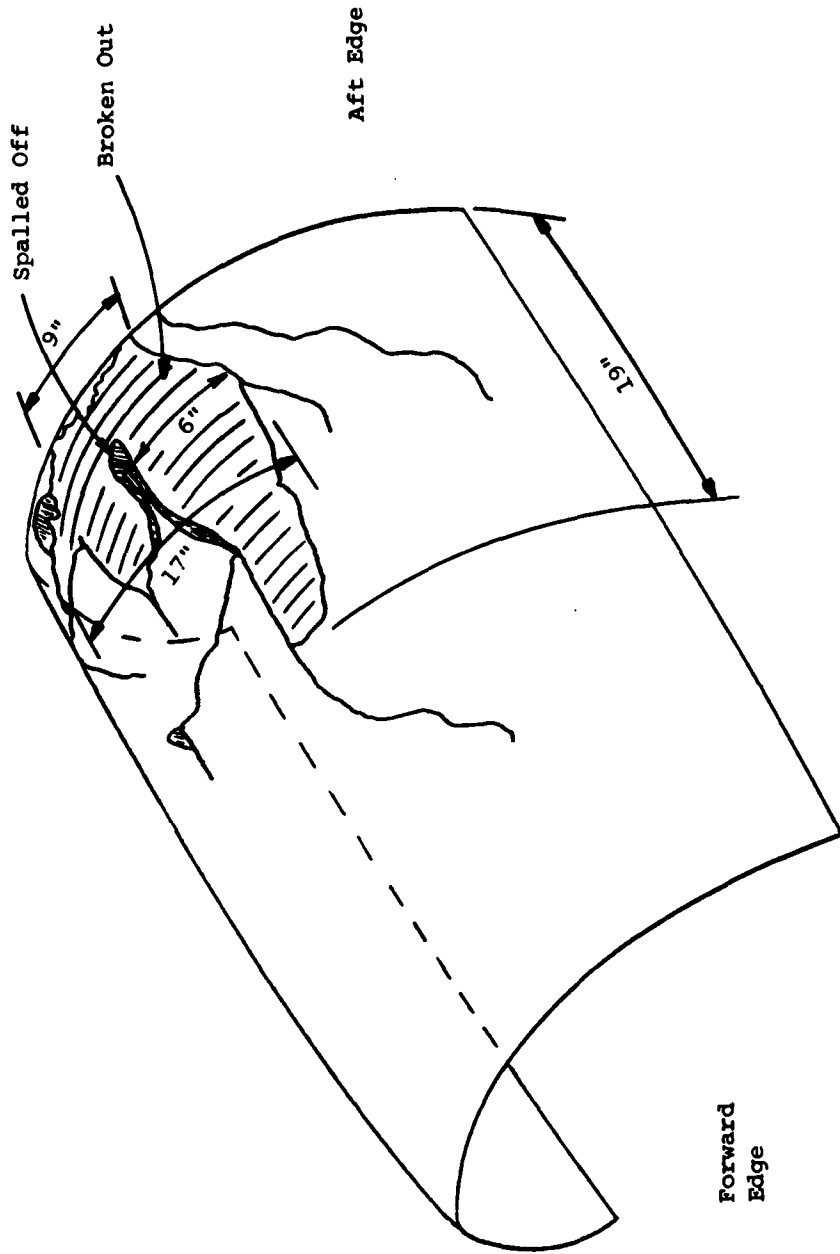
attachment screws. The canopy failed catastrophically at the aft bow frame without any bird penetration of the cockpit area. One large piece of acrylic (10"x5"), two smaller pieces (2"x4") and several 1"x1" pieces were found inside the cockpit. The bird was not completely pulverized as several large pieces were found intact behind the test fixture. Review of the motion pictures revealed that a stress wave formed following impact and traveled aft reaching the aft arch of the forward canopy at approximately the same time that the bird carcass passed over. A reflection wave of significant magnitude traveled forward over the pilot's head position as the transparency failure occurred. The bird orientation at impact looked good. The characteristics of the failure are documented in Figures B-4 and B-5.

1. Canopy failed at aft bow-frame (see photograph and sketch, Figures B-4 and B-5).
2. Zero bird penetration.
3. One large piece acrylic inside (10" x 15") in front floor area plus two intermediate 2" x 4" pieces (one in floor, one in front of instructor's windshield). Several smaller particles 1" x 1" or less inside.
4. Bird not completely pulverized, some fairly large pieces intact.

Figure B-4. Sketch of T-38 Forward Canopy After Test No. 635.

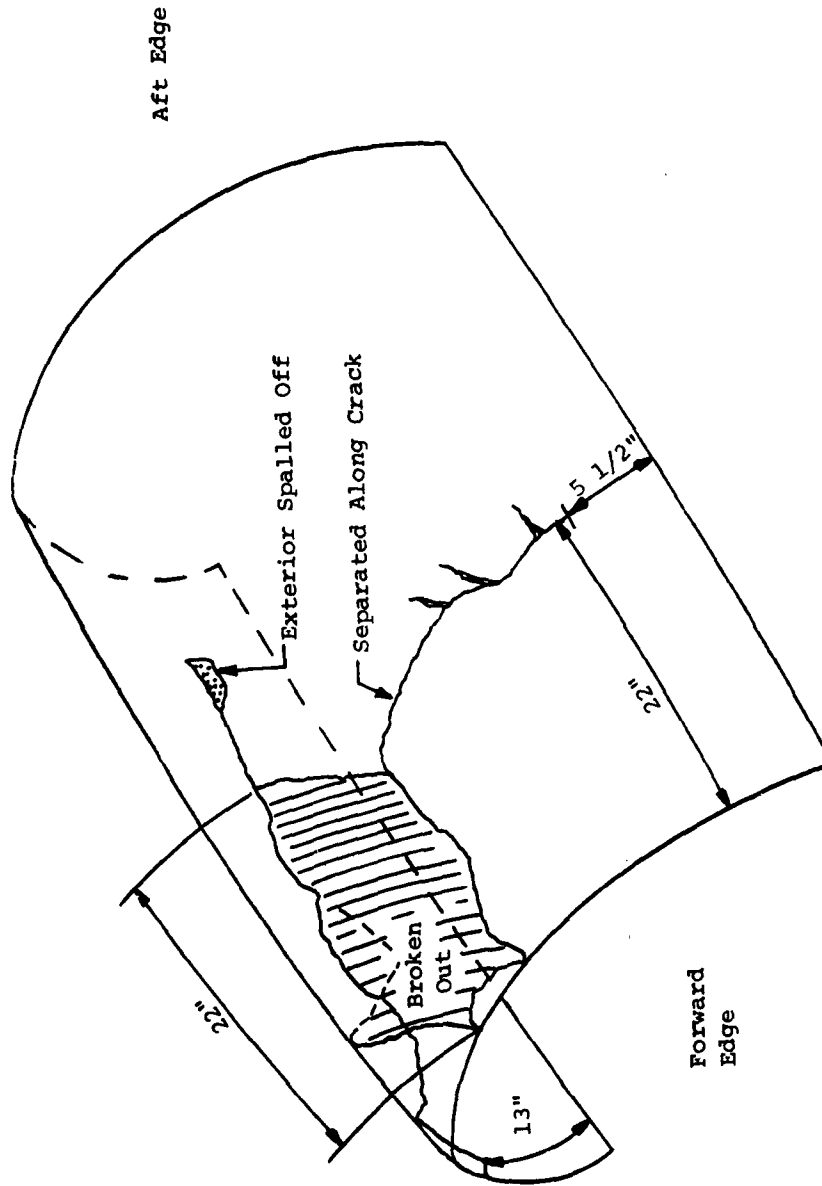
Test No. 640 was the fifth shot at impact location 4 and achieved an actual velocity of 178 knots versus the 180 knots desired. All test hardware had been previously utilized in tests 636, 637, 638, and 639. There was little deflection of the canopy prior to failure in the impact area. The initial impact was at the forward canopy frame causing some flattening of the forward former in the centerline area. Cracks in the acrylic appear to originate in the leading edge of the transparency propagating outboard and aft prior to complete failure of the acrylic. The majority of the bird penetrated the canopy and impacted with enough force on the plexiglass shield directly in front of the instructor's windshield to break the instructor's windshield. Since the 0.5 inch plexiglass was not in direct contact with the instructor's windshield, it must have flexed under the impact forces and impacted with sufficient force to crack the instructor's windshield. Beside the bird, there was a large amount of acrylic in the forward cockpit that would have presented a hazard to the crew member, including one piece approximately 4 square inches in size. The change in gap between the windshield frame and forward canopy bow was sufficient to be visibly noticeable. The characteristics of the failure are shown in Figures B-6 and B-7.

1. Canopy broke out at forward former (see sketch and photograph, Figures B-6 and B-7).
2. Noticeable change in windshield - canopy frame gap (see Table 2).
3. Broke instructor's windshield and 0.5 inch plexiglass protective plate in front of it.
4. Slight flattening of forward former at the centerline and looks like rear frame of windshield flattened slightly.
5. Majority of bird in cockpit.
6. Appears mirror mounts might have touched canopy but no damage apparent above either one.
7. No readily visible change in seam along forward retainer and transparency does not appear to have pulled loose significantly if at all from the forward retainer.

Figure B-6. Sketch of T-38 Forward Canopy After Test No. 640.

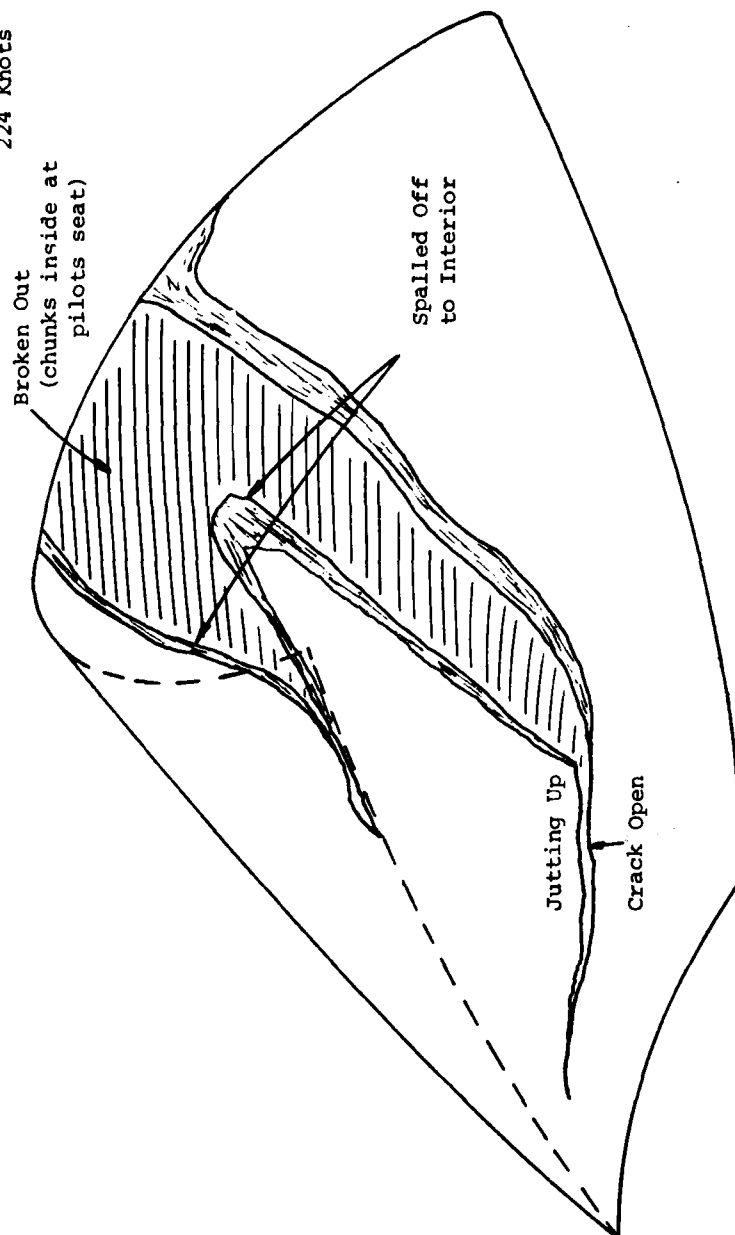
Test No. 642 was the second shot at impact location No. 2 on the forward windshield. All test hardware was the same as was used for Test No. 641. The planned impact velocity was 230 knots and the actual impact velocity was 224 knots. The windshield failed catastrophically with failure initiating under the point of impact and propagating aft to the arch frame and forward towards the front bulkhead. Several pieces of the acrylic windshield, including some large pieces, entered the cockpit and would have impacted the pilot. Approximately 50 percent of the bird mass entered the cockpit and would have impacted the pilot. This test established the threshold of failure at this location at less than 224 knots. The characteristics of the failure are shown in Figures B-8, B-9, and B-10.

1. Failure point of forward windshield at or below 224 knots.
2. Apparently there is some energy transmitted to the canopy and frame during impact event.

Figure B-8. Sketch of T-38 Forward Windshield After Test No. 642.

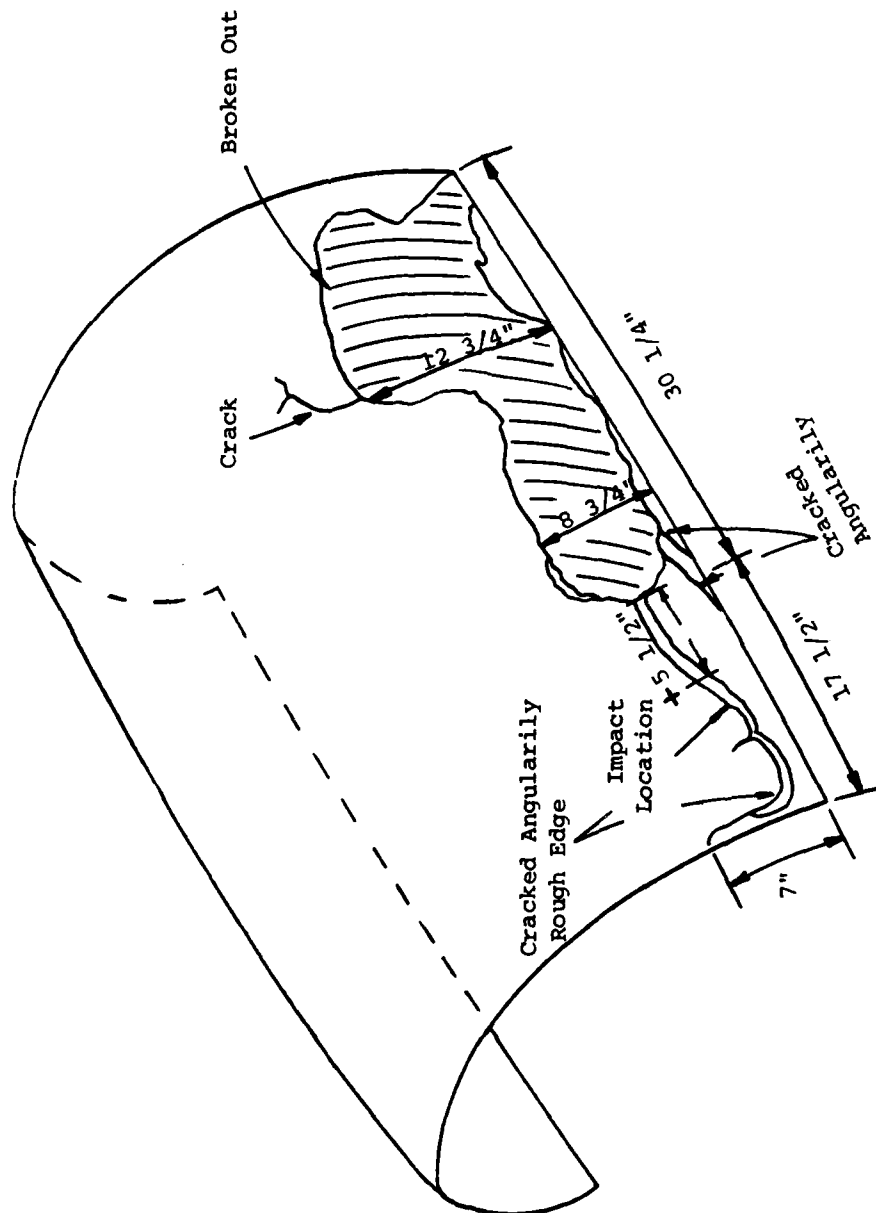
Test No. 644 was the second shot at impact location No. 6 on the forward canopy. All test hardware was the same as was used for shot No. 643. The planned impact velocity was 145 knots and the actual impact velocity was 141 knots. The bird was partially out of the bag and appendages were flailing at impact. However, the center of gravity of the bird was on target. The canopy failed by fracture. Failure appeared to initiate at the frame and propagated rapidly with large pieces of acrylic breaking out under the bird. Considerable deflection along the hinge line was observed as the bird traveled aft. A majority of the bird and much of the plexiglass remained outside the cockpit (for this condition of no aerodynamic flow). Approximately 20 to 25 percent of the broken acrylic was found inside the cockpit including two pieces 3x4 inches in the front cockpit and several pieces 2x4 inches in the rear cockpit. About 20 percent of the bird mass was either inside the cockpit or trapped in the framework. There was no apparent damage to the hinge pin or nodes. The fiberglass material was torn from a point where the clear area of the panel starts to a point just forward of the 25th node. Cracking of the acrylic occurred under the fiberglass material. This test established the upper limit on the failure velocity for this condition at 141 knots. The characteristics of the failure are shown in Figures B-11, B-12, B-13, and B-14.

Figure B-11. Sketch of T-38 Forward Canopy After Test No. 644.

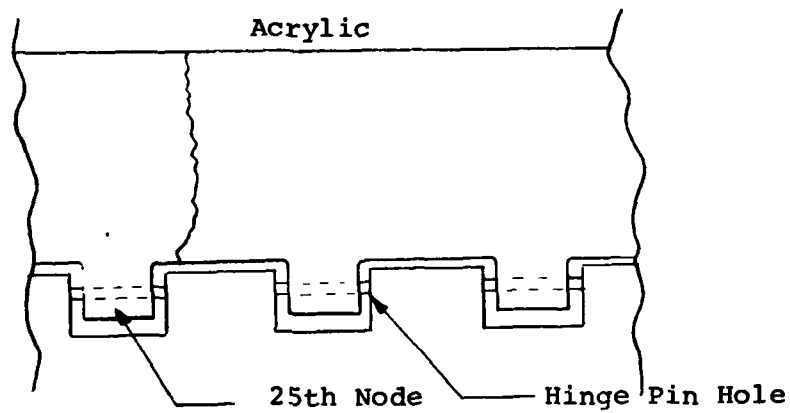
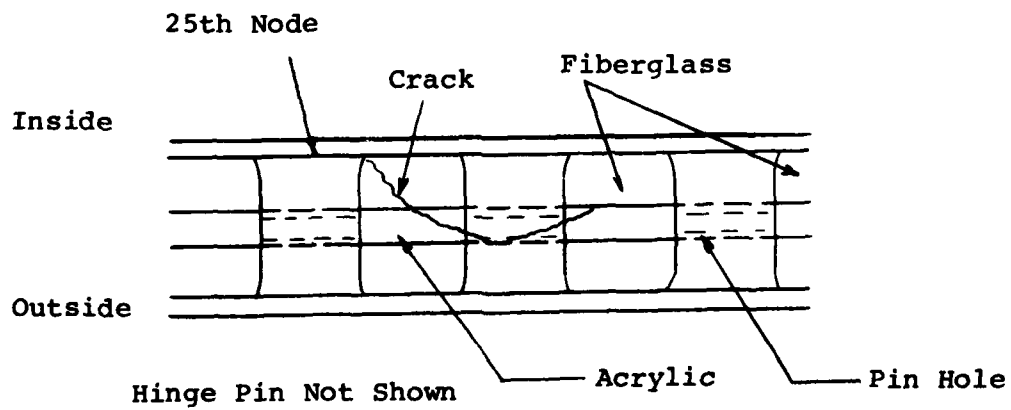
Figure B-12. T-38 Canopy Edge Failure Resulting from Test No. 644.

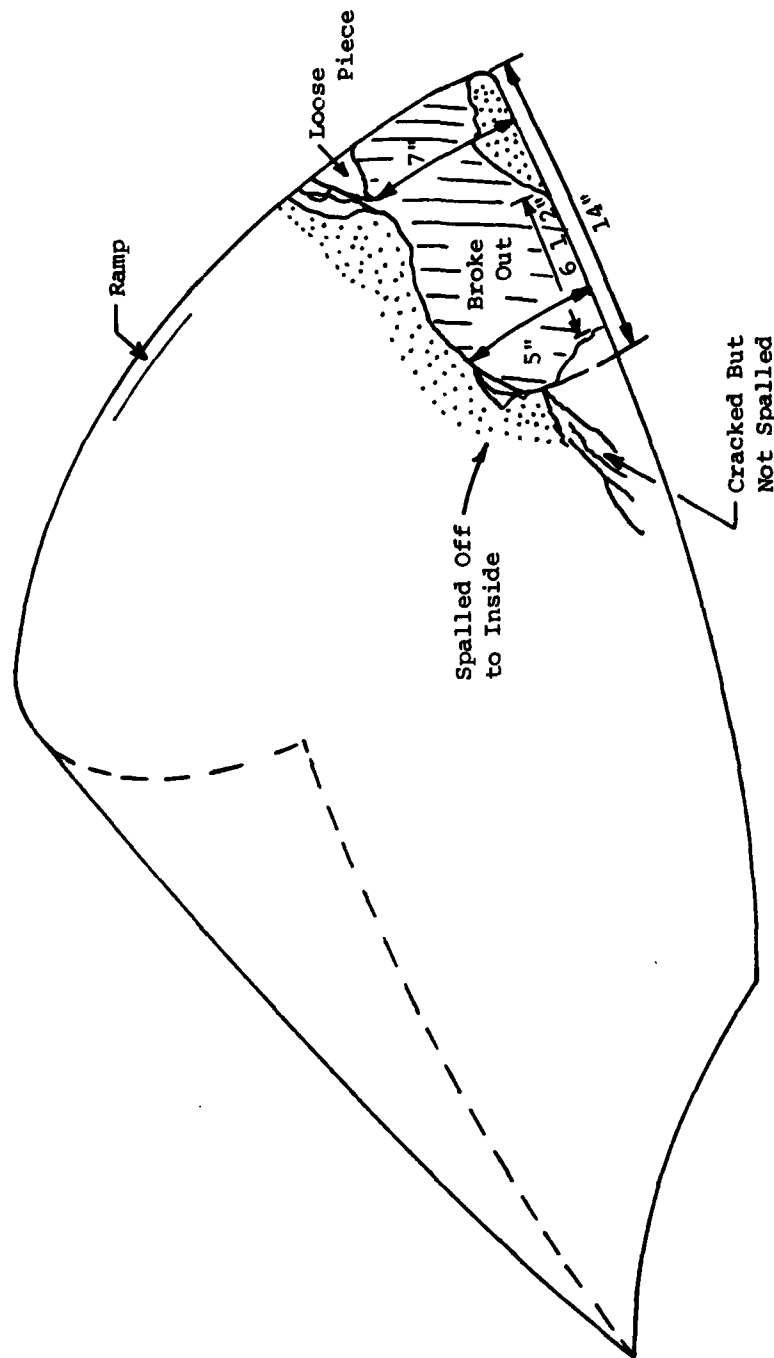
Test No. 646 was the second shot at impact location No. 3 on the forward windshield. All test hardware was the same as was used for shot No. 645. The planned impact velocity was 250 knots and the actual impact velocity was 247 knots. A section of the windshield approximately 6x14 inches was broken out at the aft rear corner. It appeared that all of the broken acrylic entered the cockpit as did 20 to 30 percent of the bird mass. Some spalling of the inside surface of the acrylic around the fracture occurred. The fiberglass edge was broken out around the boundary of the fracture area as was the outer surface ramp along the aft arch area. This test established the upper limit of the capability at less than 247 knots for this impact condition. Characteristics of the failure are documented in Figures B-15, B-16, and B-17.

Figure B-15. Sketch of T-38 Forward Windshield After Test No. 646.
